MDI was commissioned to perform routine data analysis at a Pulverized Coal Mill. Outer race defects were found on two machines:

- ▶ Gland Steam Condensation Fan
- ▶ Service Water Pump

Case Study: Outer Race Bearing Defect

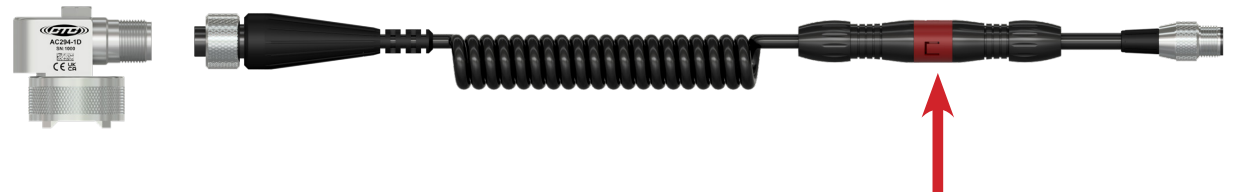
Utilizing a cable with a breakaway safety feature for portable data collection (as shown here) is extremely important for analyst safety while collecting data on large operating machinery

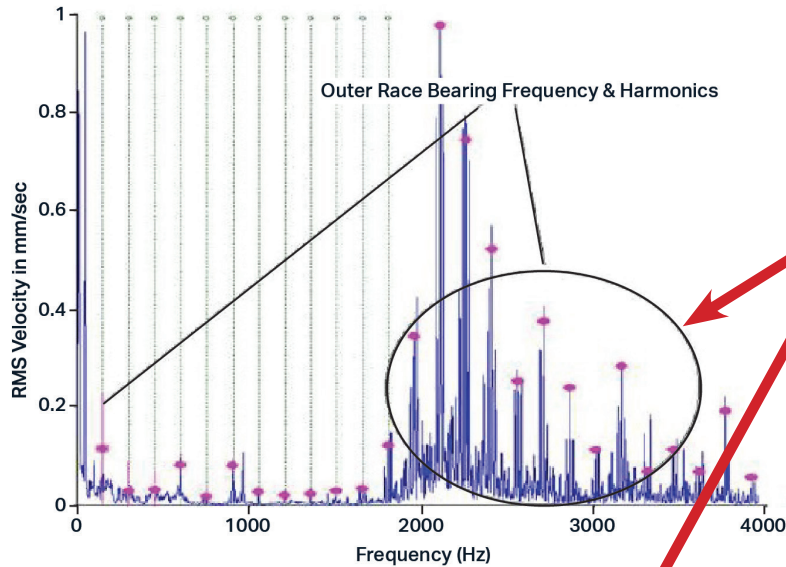
Both motor drive end bearing velocity and the Peakvue spectrum showed elevated vibration at the outer race defect frequency indicative of bearing fault

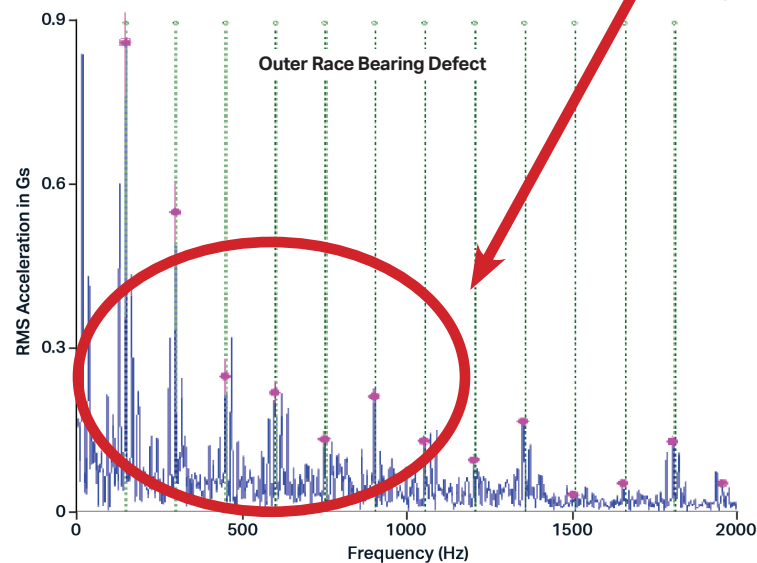
From bearing inspection it was found that false brinelling is the root cause of the failure

Other types of outer race bearing defects include cracking, which occurs due to high static loads, and fretting, which occurs due to micro-movements between the bearing and the housing or shaft. Fretting can cause wear and damage to the bearing surface and can result in premature bearing failure. Fretting can be seen on machine 2 (pictured on page 3), the service water pump. In both cases, it was recommended to replace the bearing to prevent further damage.

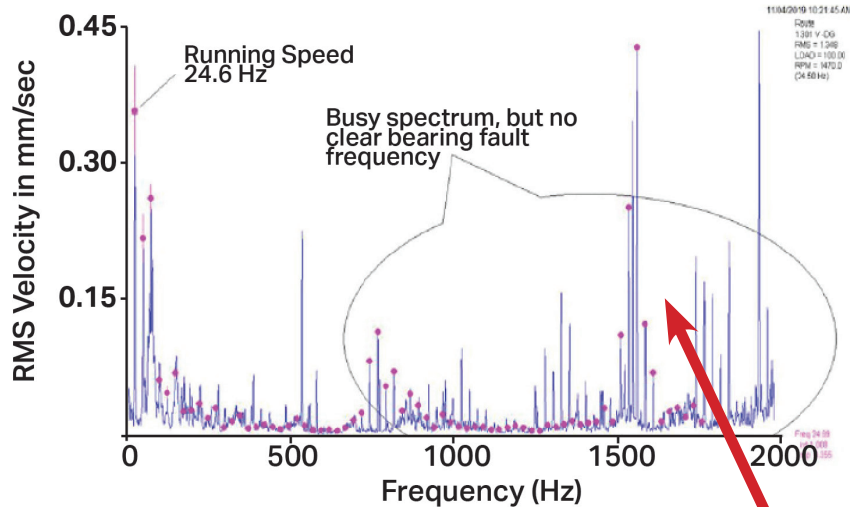
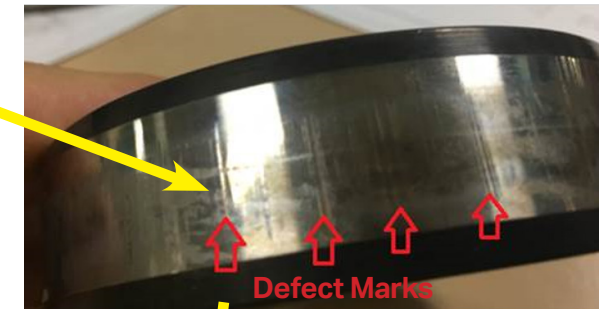
From bearing inspection it was found that false brinelling is the root cause of the failure.
